NPDES Inspection Report

Permit # WAR003375

IKO Pacific, Inc.

October 7, 2015

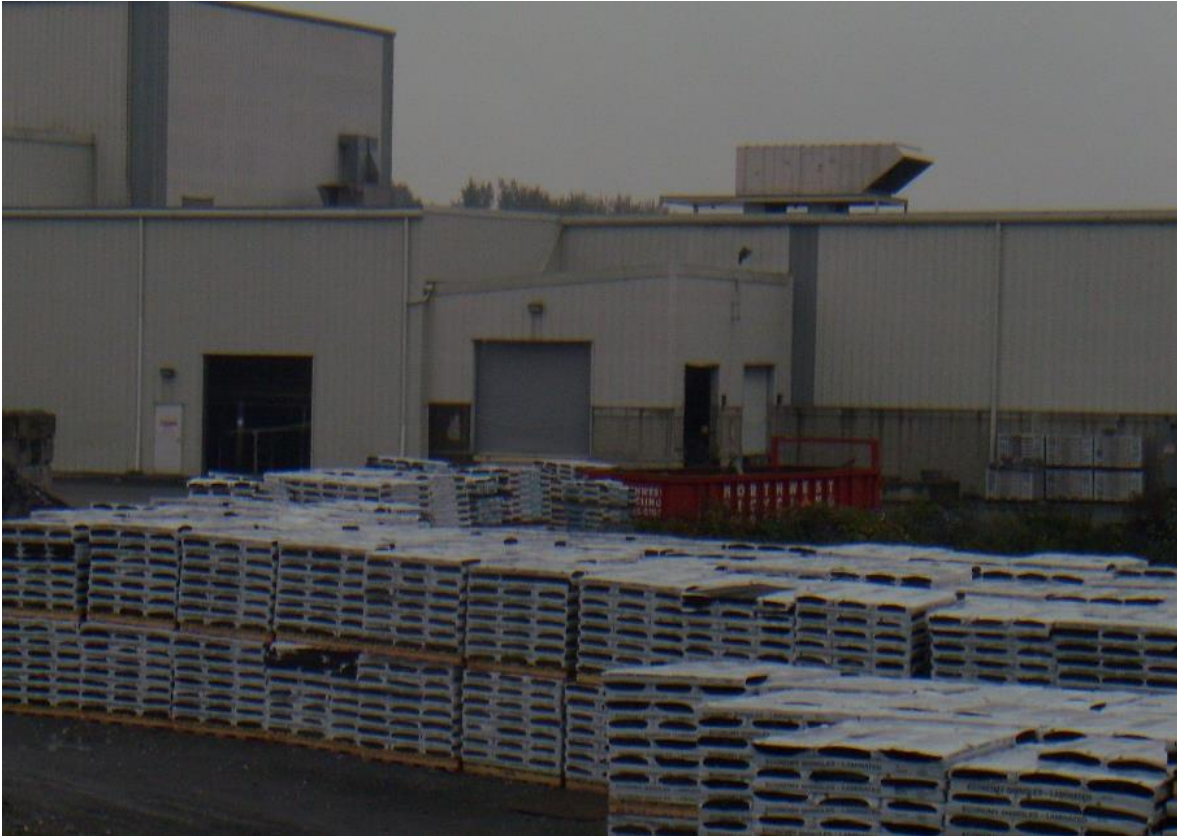
We inspected areas in the southwest portion of the facility where finished shingles (**Photo 1**), gravel and crushed limestone (**Photo 2**) were stored outdoors. In this area, we observed an uncovered dumpster (**Photo 1**) used to collect metal for recycling. To the northwest of the limestone storage area, we observed a storm drain receiving turbid stormwater (**Photo 3**). We noted that storm drains throughout the facility were equipped with filters. Mr. Belcher said that the facility inspects and maintains storm drain filters on a monthly basis.

During the inspection, we observed one dumpster left uncovered while not in use (**Photo 1**) and one dumpster left partially uncovered while not in use (**Photo 4**).

Photo 1 / SI850222 – Eastern view of a red uncovered dumpster in the southwest portion of the facility. This is a cropped version of the original photograph.

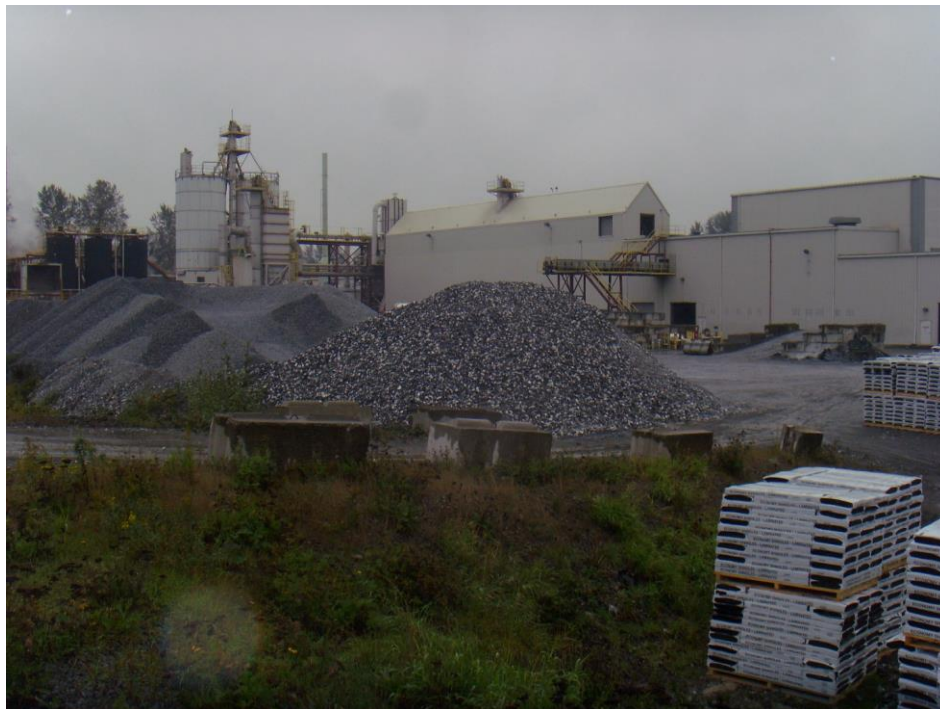
Photo 2 / SI850221 - Northeast view of the limestone storage area.

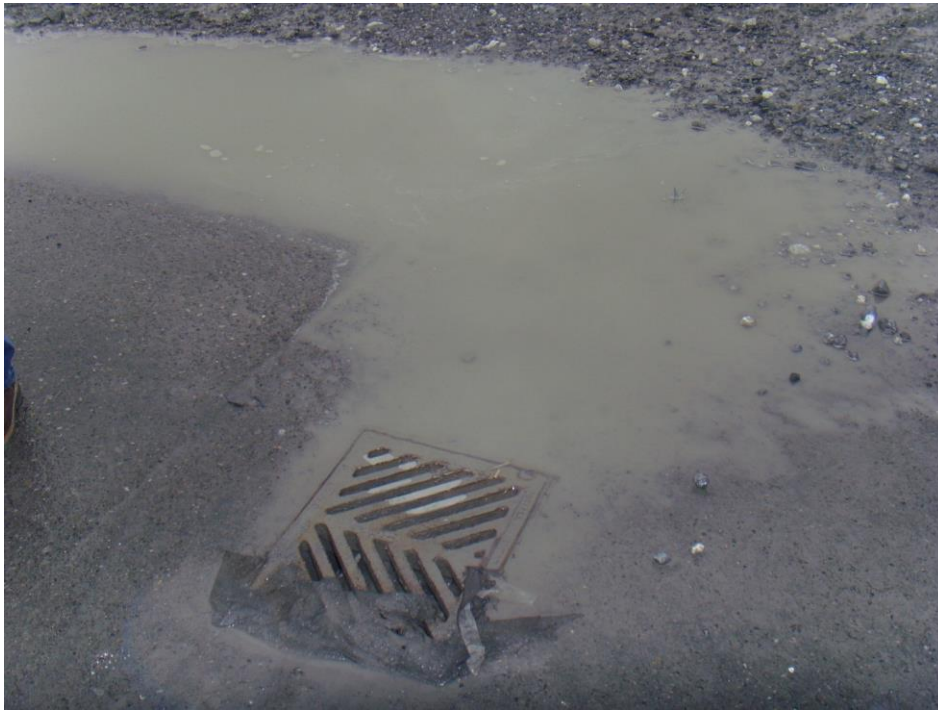
Photo 3 / SI850225 – View of a storm drain located northeast of the limestone storage area.

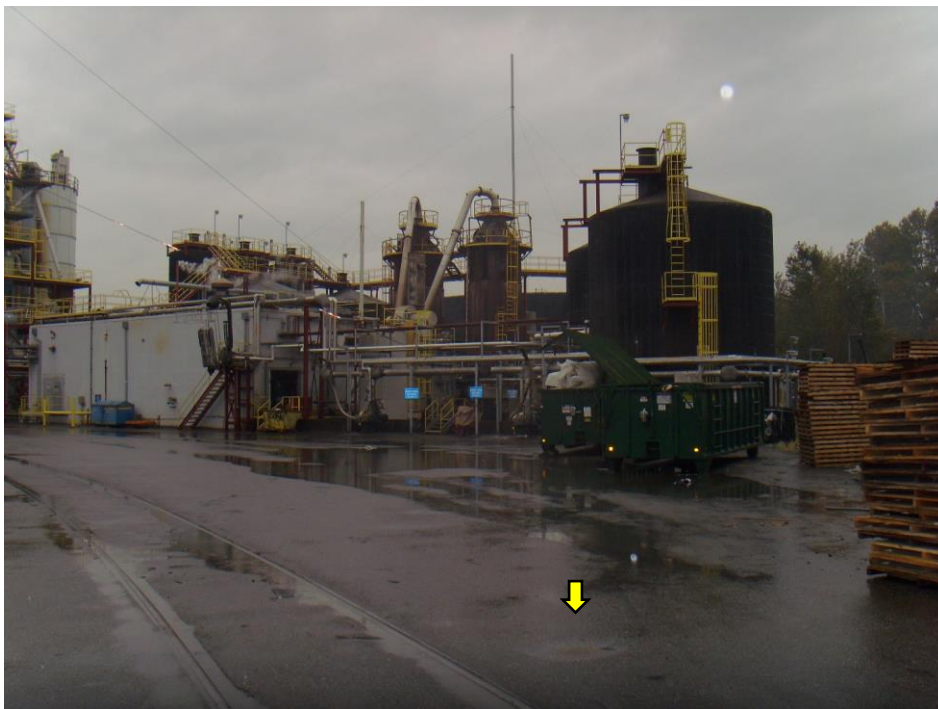
We inspected the truck unloading area on the east side of the tank farm. We observed a partially open dumpster and sheen on the pavement (**Photo 4**). In this area we also inspected an oil/water separator. Mr. Belcher said that BAI Environmental Services performs annual maintenance on the oil/water separator. Upstream of the oil/water separator, we observed a storm drain receiving turbid stormwater (**Photo 5**). We inspected the ferrous chloride unloading station, where we observed evidence of corrosion on the containment wall of the tank farm (**Photo 6**).

Photo 4 / SI850189 – Southwesterly view of the truck unloading area and tank farm. A green dumpster with a partially open lid appears near the center of the photograph. The yellow arrow indicates the location of sheen on the pavement in the foreground.

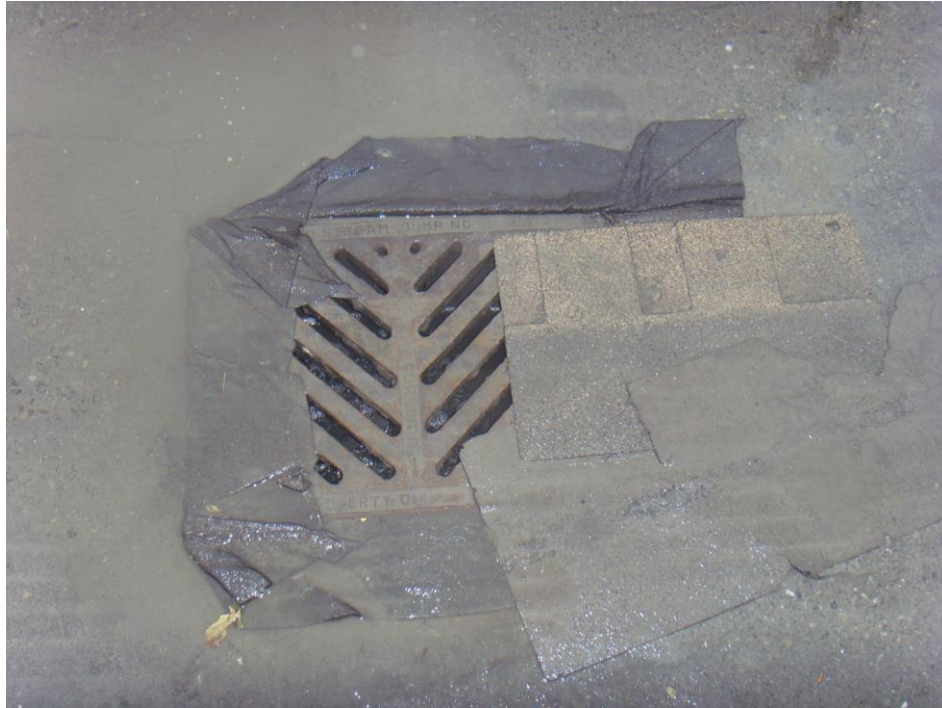
Photo 5 / SI850196 – Stormwater drain immediately upstream of the oil-water separator located north of the truck unloading area.

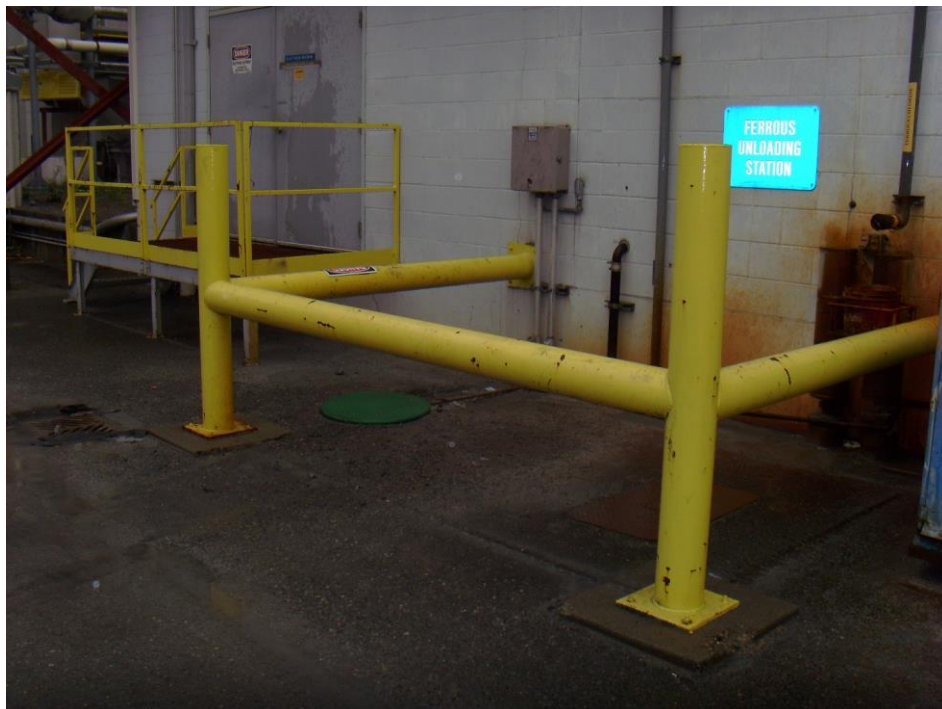
Photo 6 / SI850202 – Southwesterly view of the ferrous chloride unloading station located near the tank farm. Rust discoloration appears along the wall and a storm drain appears on the left.

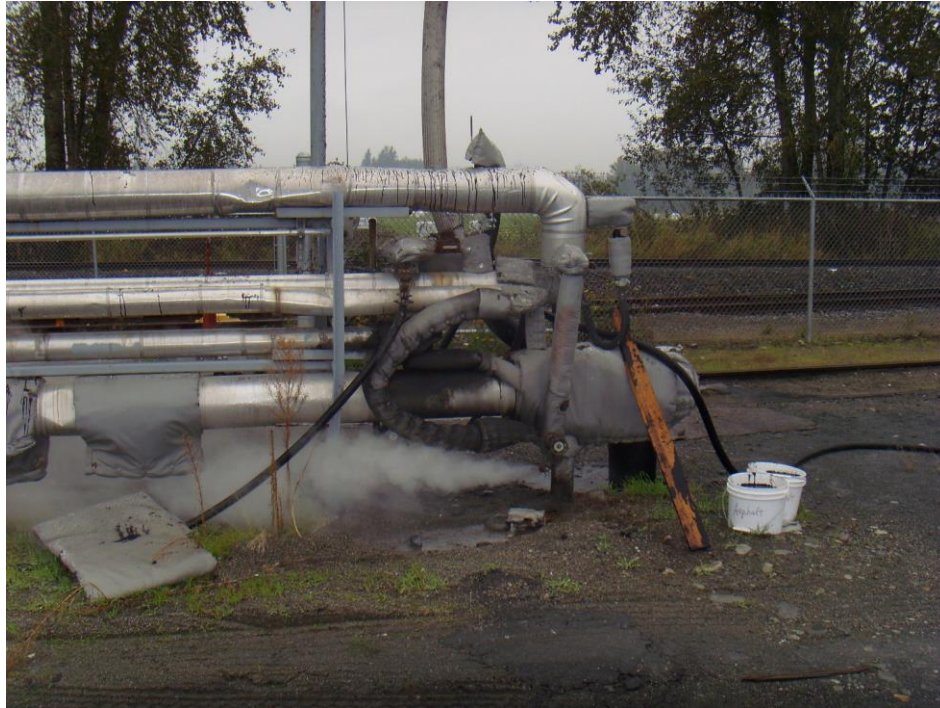
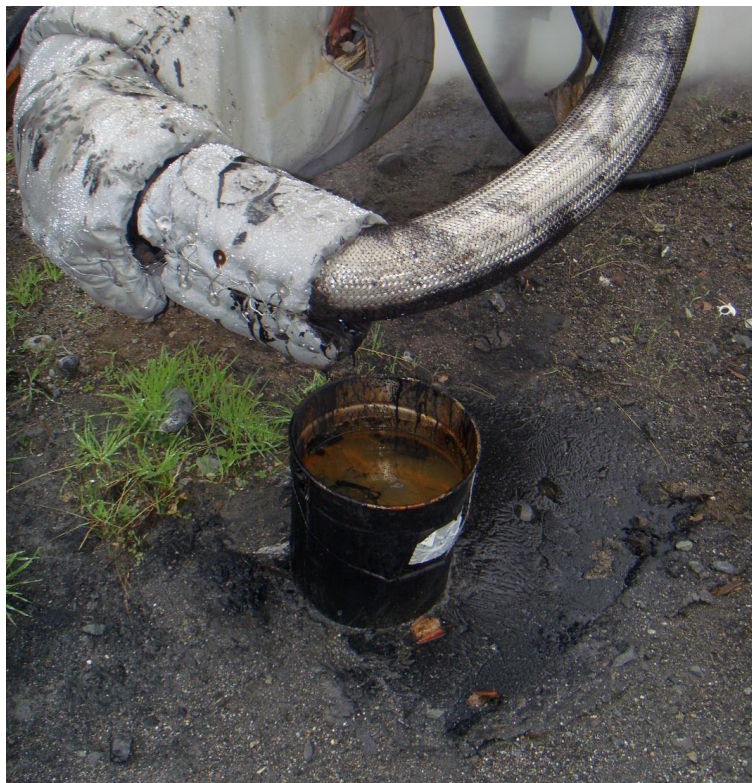
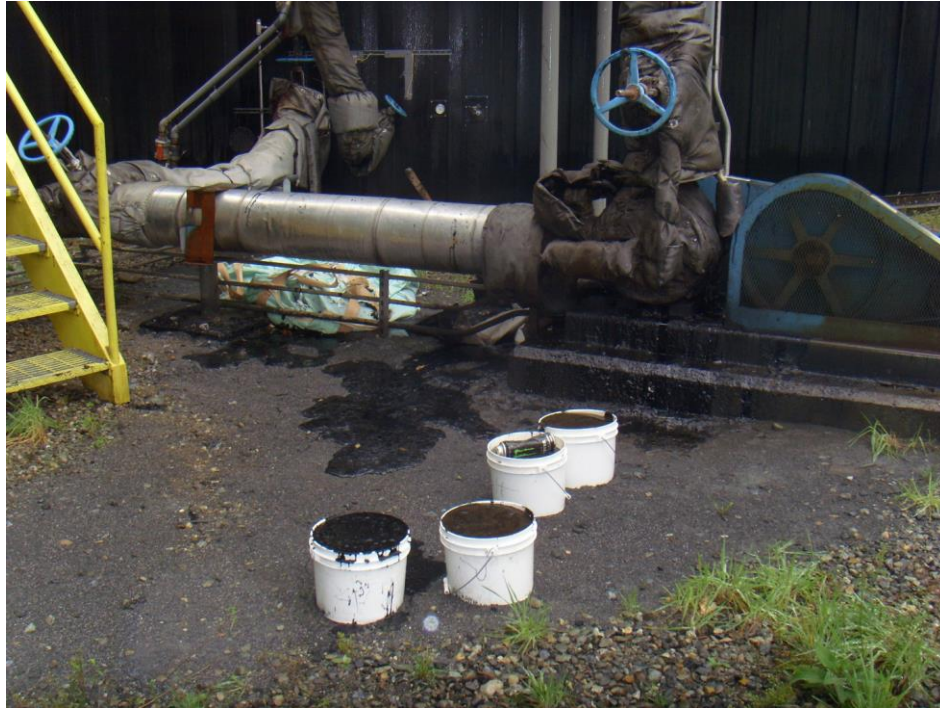
Along the northern boundary of the facility we inspected the train unloading area, where we observed uncovered buckets of spilled asphalt material (**Photos 7-9**). We also observed a parts washer and oily pieces of equipment stored outside along the concrete containment wall of the tank farm (**Photo 10**).

In the vicinity of the train unloading area along the northern boundary of the facility, we noted a few areas where debris or contaminants could contribute pollutants to stormwater. We observed uncovered buckets of spilled asphalt material (**Photos 7-9**). We also observed stained concrete where a parts washer and oily pieces of equipment were stored along the containment wall of the tank farm (**Photo 10**). We suggested that the facility consider practices for containing or cleaning up contaminants in the train unloading area.

Photo 7 / SI850191 – Northerly view of the train unloading area along the northern boundary of the facility. White buckets containing spilled asphalt appear on the right.

Photo 8 / SI850192 – Detail view of a bucket of spilled asphalt material located near the buckets that appear in the previous photo. This is a cropped version of the original photograph.

Photo 9 / SI850216 – Buckets containing spilled asphalt material located between flux tanks #10 and #11.

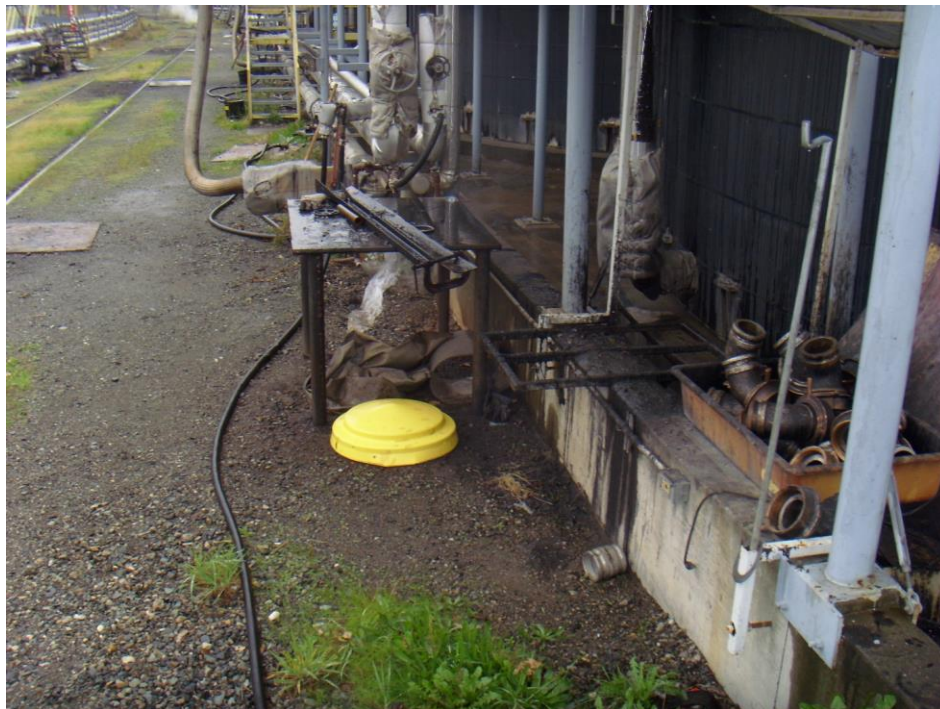
Photo 10 / SI850211 – Northeasterly view of oily parts and stained concrete. The train unloading area appears on the left. A parts washer appears on the right along the concrete containment wall of the tank farm.

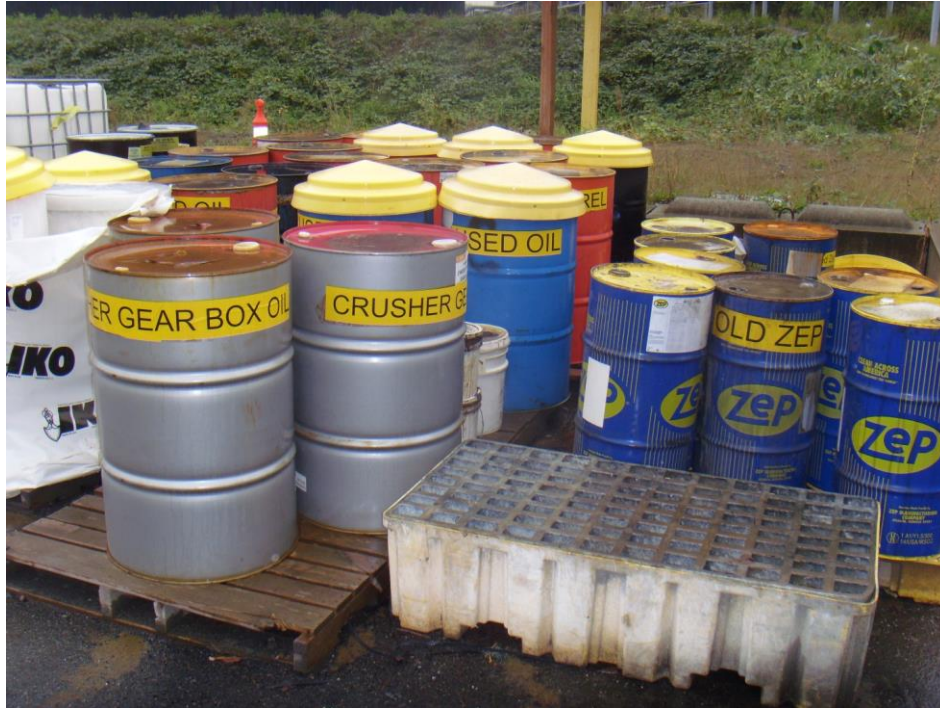
Within the tank farm containment area, we observed drums of oil and cleaning products (**Photo 11**) with exposure to stormwater. Mr. Belcher explained that runoff from this area enters a sump (**Photo 12**). He said that sumps within the tank farm containment area are manually pumped to the oil/water separator in the truck unloading area.

Photo 11 / SI850207 – Drums of used oil and cleaning products on the west side of the tank farm containment area.

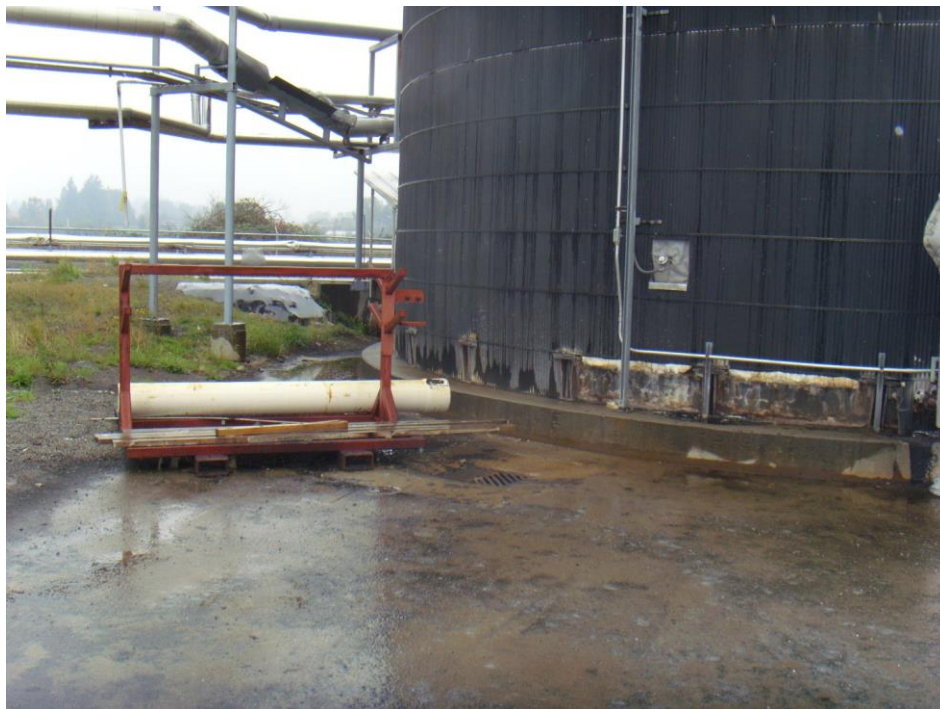
Photo 12 / SI850209 – Northerly view of the paved area to the east of the drums that appear in the previous photo. The grate in the center of the photo indicates the location of a sump that receives runoff from this area.

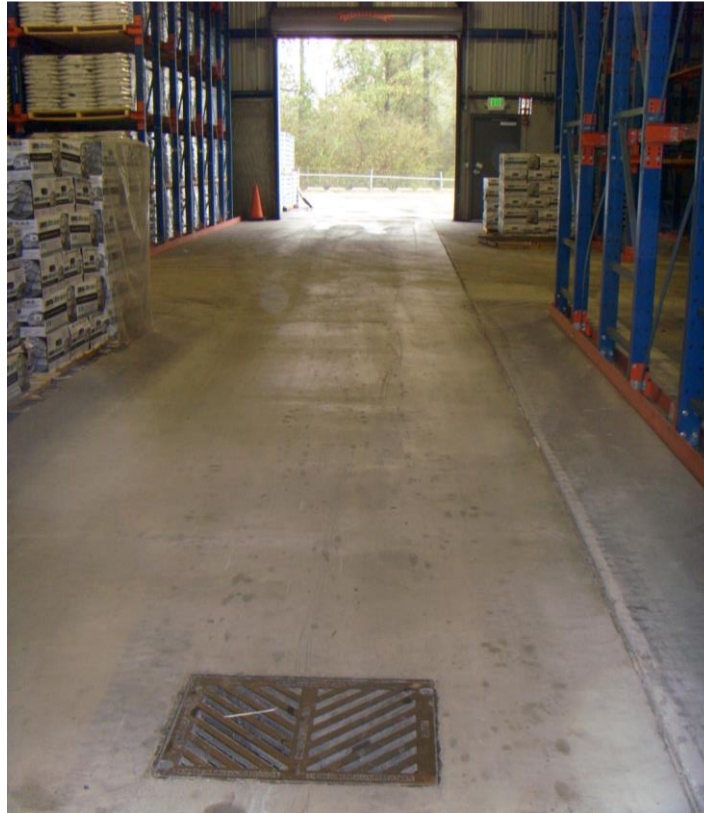
On the east side of the facility we inspected a warehouse, which had recently been expanded to enclose old stormwater drains (**Photo 13**). I asked if these floor drains are still connected to the stormwater collection system and whether process wastewater enters these drains. Mr. Belcher said that the floors are swept clean and that process wastewater is not generated in this area. In an email on October 21, 2015 (**Attachment E**), Mr. Belcher confirmed that the floor drains had been disconnected from the stormwater system.

Photo 13 / SI850230 – Easterly view of a floor drain inside the warehouse building on the east side of the facility. Floor drains in this area previously received stormwater until they were enclosed by a warehouse expansion project in 2012. This is a cropped version of the original photograph.

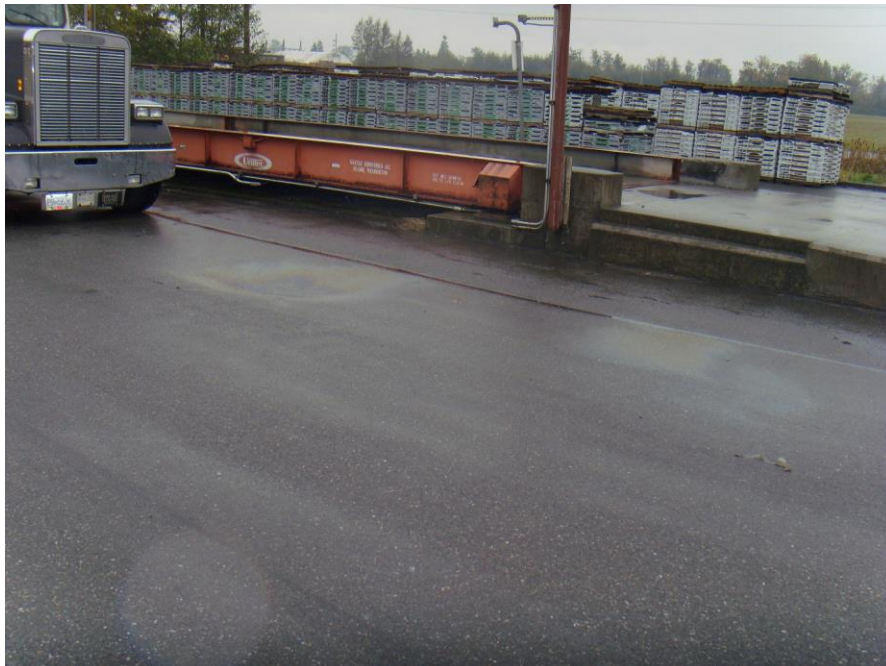
In the southeast corner of the facility, we observed sheen on the pavement (**Photo 14**) in the area that drains to a bioswale (**Photo 15**) upstream of sampling point #3. We inspected additional stormwater conveyances, which included a vegetated drainage ditch (**Photo 16**) upstream of sampling point #2 (**Photo 17**) and the stormwater detention pond (**Photo 18**) upstream of sampling point #1. The facility delivers samples to Avocet Environmental Testing in Bellingham, WA for analysis.

Photo 14 / SI850231 – View of sheen on the pavement at the truck weigh station at the southeast corner of the facility.

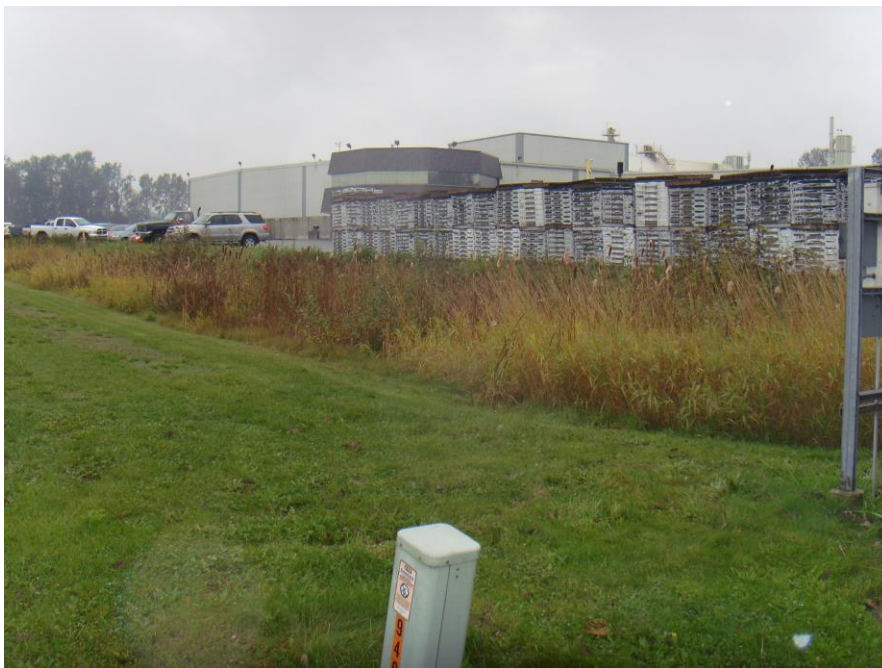
Photo 15 / SI850233 – Westerly view of the bioswale at the southeast corner of the facility.

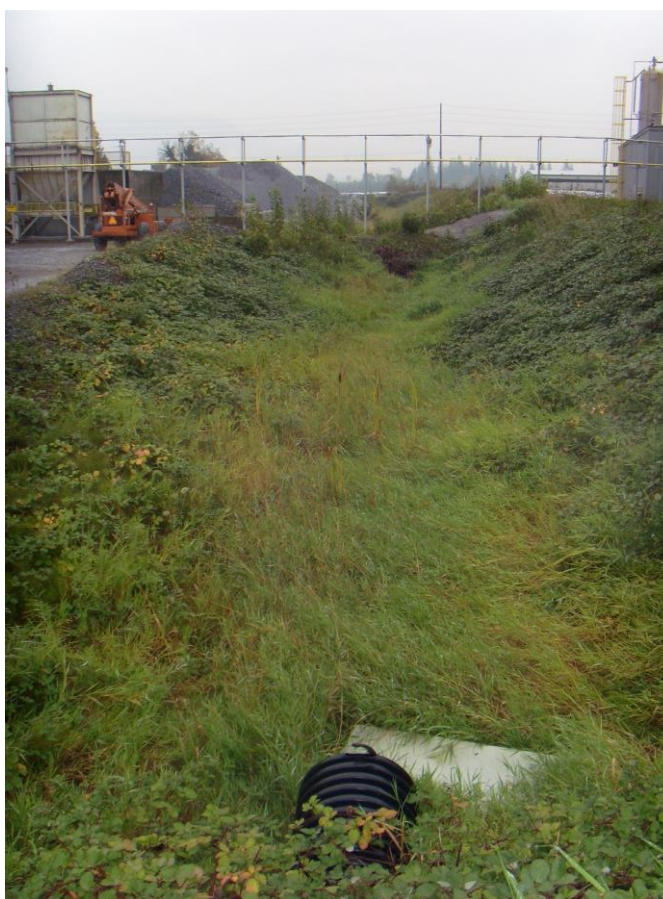
Photo 16 / SI850213 – Southerly view of the drainage ditch routed to the outfall at sampling point #2.

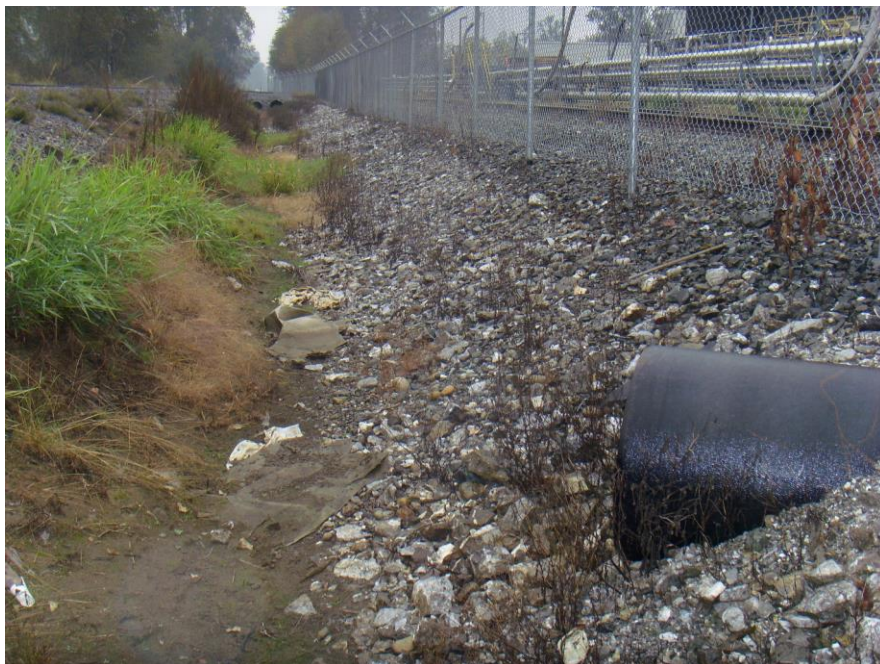
Photo 17 / SI850226 – Easterly view of the outfall at sampling point #2.

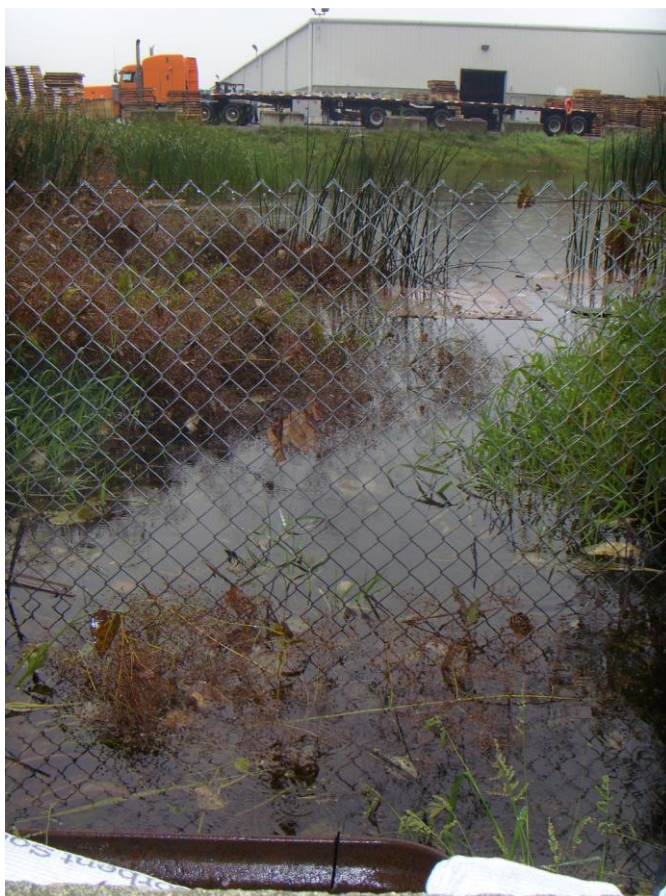
Photo 18 / SI850194 – Southerly view of the stormwater detention pond upstream of sampling point #1.
